# Use of damage in fire investigation: a review of fire patterns analysis, research and future direction

Gregory E Gorbett<sup>1,2\*</sup>, Brian J Meacham<sup>1</sup>, Christopher B Wood<sup>1,3</sup> and Nicholas A Dembsey<sup>1</sup>

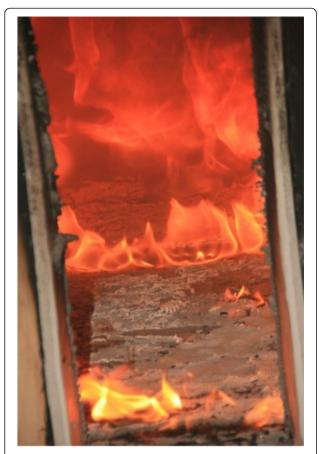
**Fig. 7** Scene photograph of suspected ignitable liquid pour (Wood *et al.* 2012)

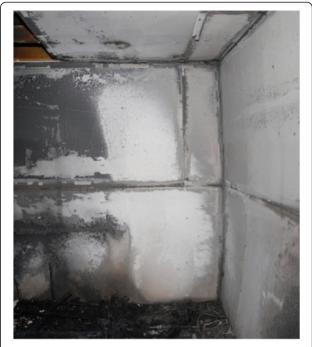
**Fig. 11** Photograph of a Plume-Generated Fire Pattern (fire origin was located at the base of this damage-test conducted at EKU by author)

In summary, the characteristics distilled from the literature is that plume-generated patterns have areas of greater magnitude of damage in relationship to the surrounding areas and because of this the lines of demarcation between these areas are described as clear or sharp. Also, the lines of demarcation are not parallel to the floor or ceiling, but are at an angle representing the buoyant flow, usually with characteristic geometric shapes (Fig. 11).
